# HOME INSPECTION REPORT

1820 Norman Way, Modesto

681221

July 24, 2026

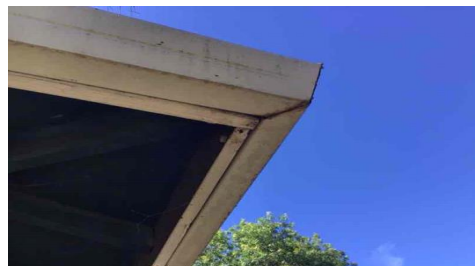
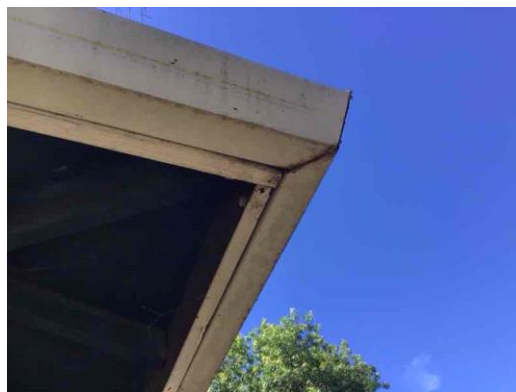
Photo 04

1. Leaks were noted in the downspouts and/or gutters. During wet weather conditions these areas are more obvious and during dry weather conditions they are noted from the stains at the areas where the leaks have occurred. We recommend all leaks be repaired.

- ! 1. Leaks were noted in the downspouts and/or gutters. During wet weather conditions these areas are more obvious and during dry weather conditions they are noted from the stains at the areas where the leaks have occurred. We recommend all leaks be repaired.  
(See Illustration 2D) (See Photo 4)

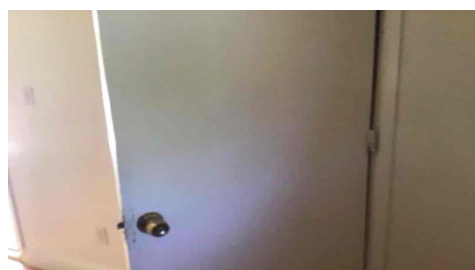
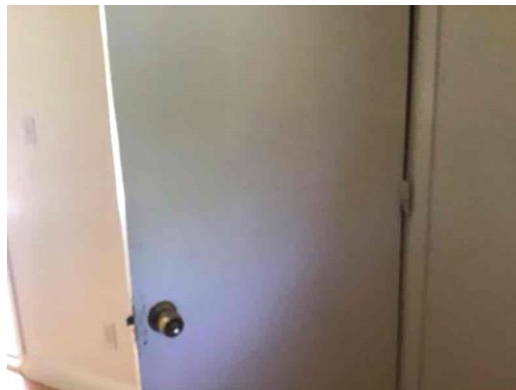
Photo 16

2. The door between the garage and the house did not have an automatic closing mechanism. The door between the garage and the interior of the house should be fitted with an automatic closing mechanism. This will reduce the potential of toxic automobile gases entering the house and serves as a fire break.

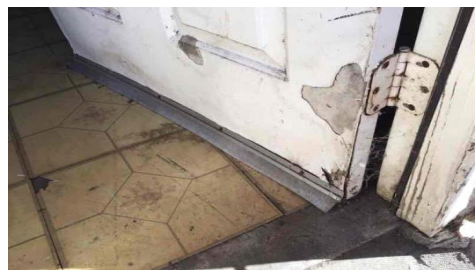
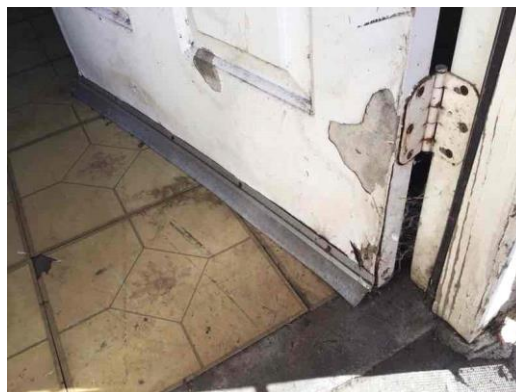
Photo 08

3. Water damage was noted at the side garage door. We recommend the services of a licensed general contractor and/or structural pest control company regarding repairs.

- ! 3. Water damage was noted at the side garage door. We recommend the services of a licensed general contractor and/or structural pest control company regarding repairs.  
(See Photo 8)

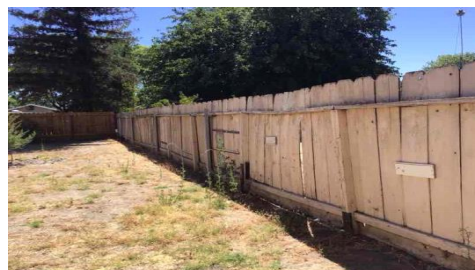
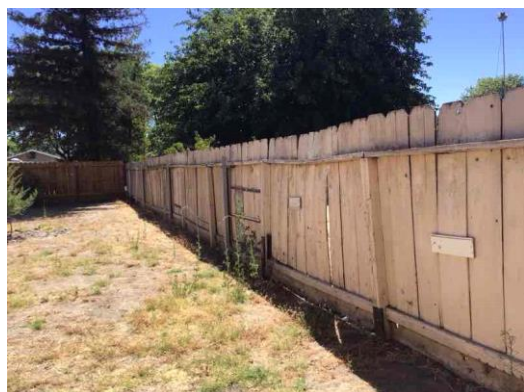
Photo 09

4. The wood fencing at the right and left of the property is in need of repairs.

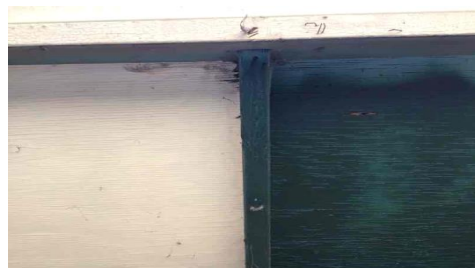
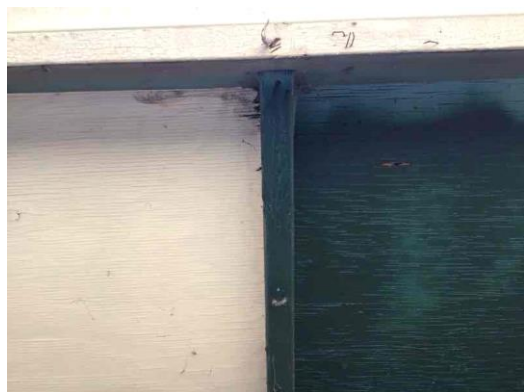
Photo 03

5. Water damage was observed to the roof eaves/sheathing at the left. We recommend the services of a licensed general contractor and/or structural pest control company.

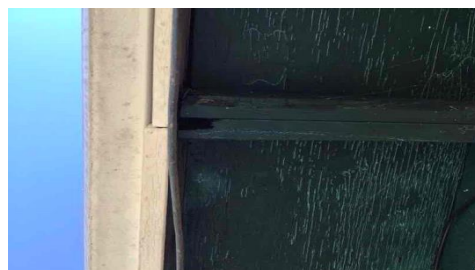
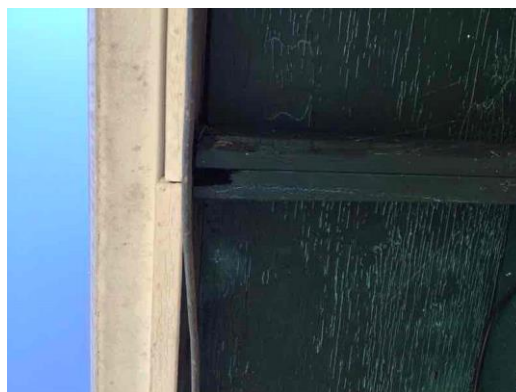
Photo 14

6. Water damage was observed to the rafter tail at the right. We recommend the services of a licensed general contractor and/or structural pest control company.

- ! 6. Water damage was observed to the rafter tail at the right. We recommend the services of a licensed general contractor and/or structural pest control company.  
(See Photo 14)

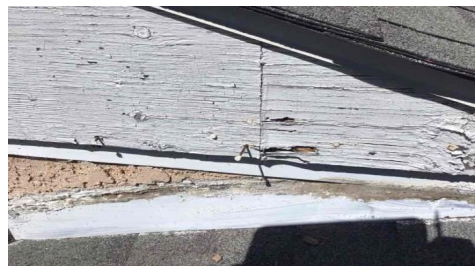
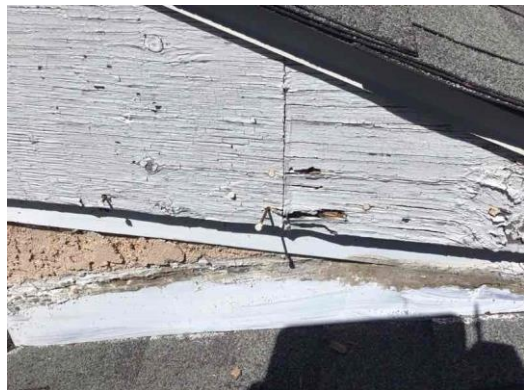
Photo 15

7. Water damage was observed to the wood siding at the upper rear exterior walls. We recommend the services of a licensed general contractor and/or structural pest control company.

- ! 7. Water damage was observed to the wood siding at the upper rear exterior walls. We recommend the services of a licensed general contractor and/or structural pest control company.  
(See Photo 15)

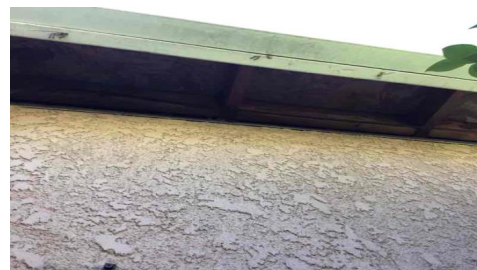
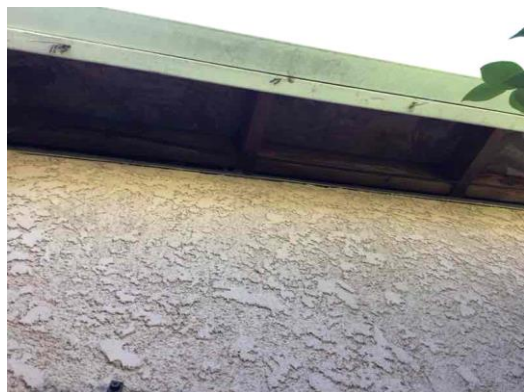
Photo 07

8. Portions of the exterior eaves/rafters are unpainted, exposed and subject to damage. We recommend priming prior to applications of a high quality exterior finish.

- ! 8. Portions of the exterior eaves/rafters are unpainted, exposed and subject to damage. We recommend priming prior to applications of a high quality exterior finish.  
(See Photo 7)

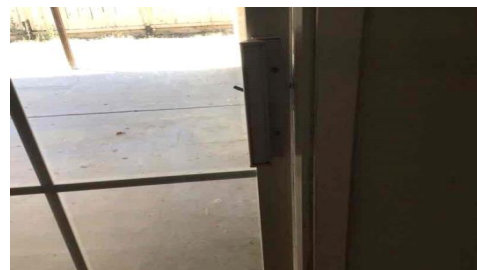
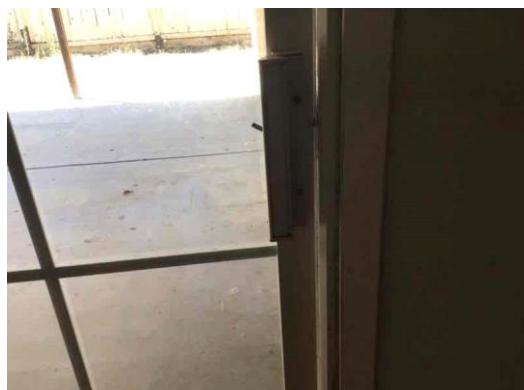
Photo 17

9. Difficult to operate or non-functional lock at the sliding door should be corrected.

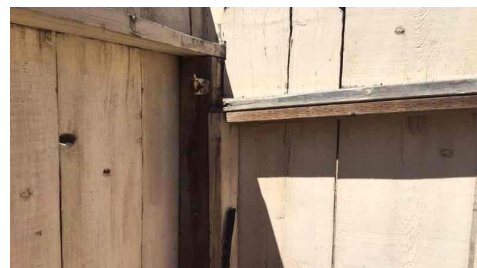
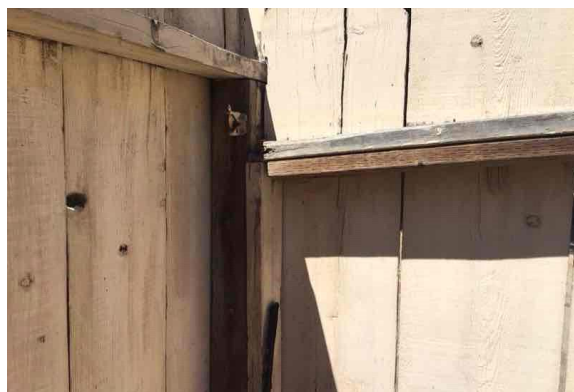
Photo 13

10. The fence gate at the left needs repair and/or adjustment in order to function properly.

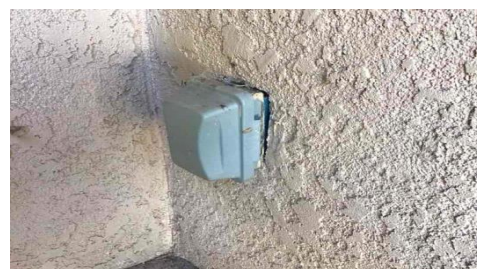
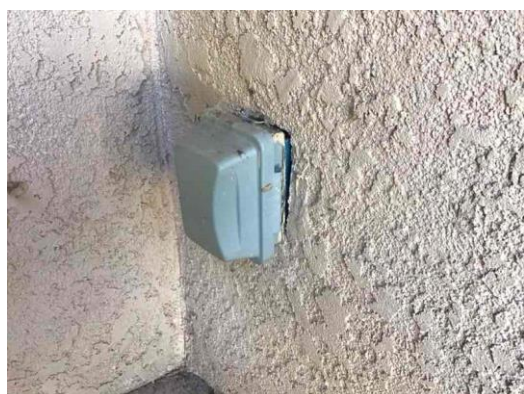
Photo 05

11. One of the outlets and/or receptacle housings at the front exterior is loose. Based upon our inspection of a representative number of outlets we recommend testing of every outlet. All loose outlets and receptacles should be repaired as necessary.

- ! 1. One of the outlets and/or receptacle housings at the front exterior is loose. Based upon our inspection of a representative number of outlets we recommend testing of every outlet. All loose outlets and receptacles should be repaired as necessary.  
(See Photo 5)

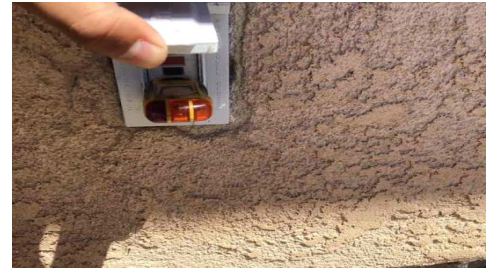
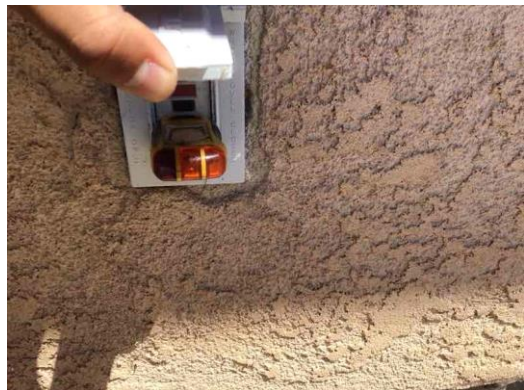
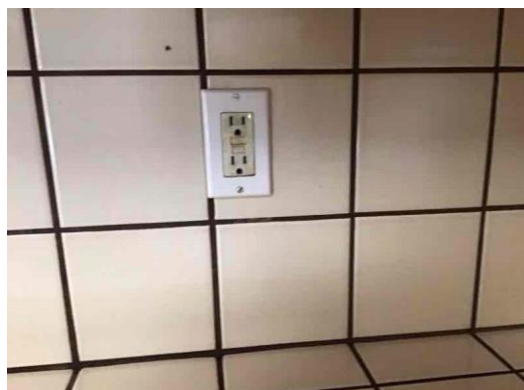
Photo 23

12. A ground fault circuit interrupter (GFCI) outlet at the right exterior and kitchen did not function or did not trip when tested with an outside source and/or the test button. This outlet and circuit should be investigated and repaired.  
([See Photo 23](#)) ([See Photo 25](#))

- ! 3. A ground fault circuit interrupter (GFCI) outlet at the right exterior and kitchen did not function or did not trip when tested with an outside source and/or the test button. This outlet and circuit should be investigated and repaired.  
(See Photo 23) (See Photo 25)

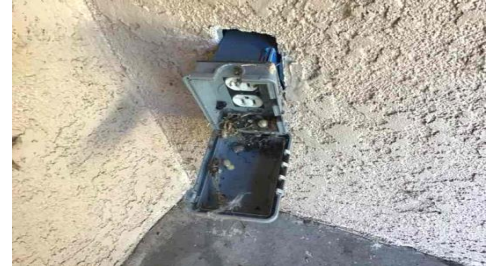
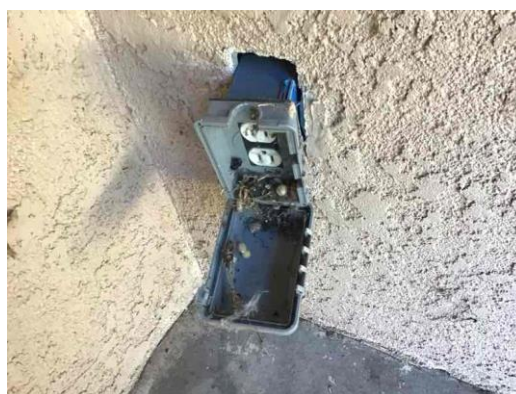
Photo 06

13. A receptacle at the front exterior is faulty or damaged. We recommend it be replaced.  
([See Photo 6](#))

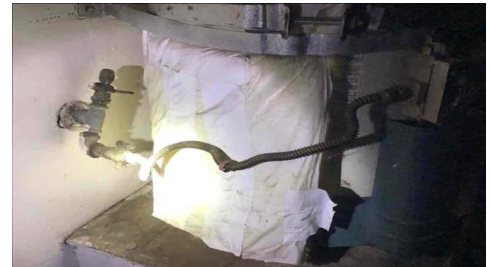
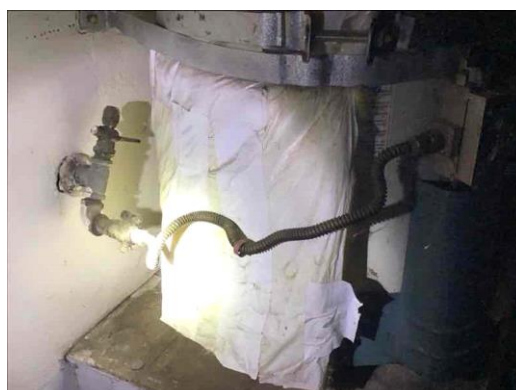
Photo 22

14. The gas line/connector at the water heater is flexible and made of brass. Brass is no longer approved for this use because it is prone to deterioration. We recommend the gas line/connectors be replaced with a line/connector meeting present standards.  
([See Photo 22](#))

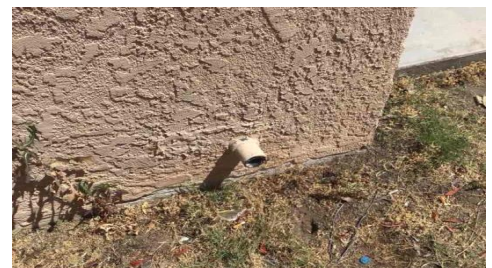
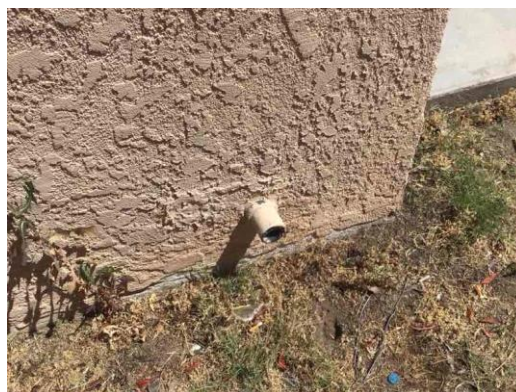
Photo 10

15. The plumbing cap is missing at the right exterior. We recommend replacing the cap to prevent odor.  
([See Photo 10](#))

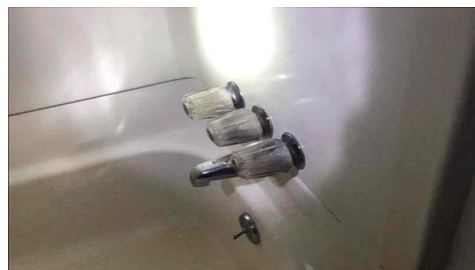
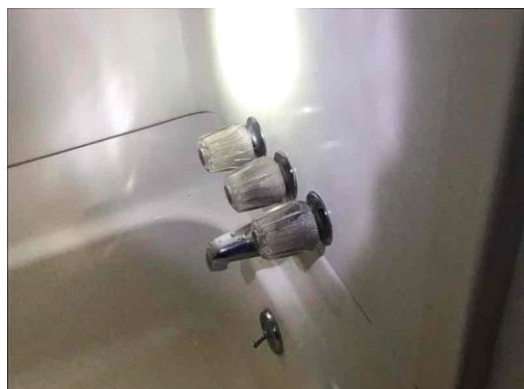
Photo 19

16. The shower faucet handles are leaking at the hall bathroom. We recommend all leaks be repaired.

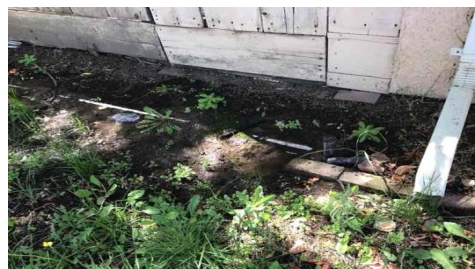
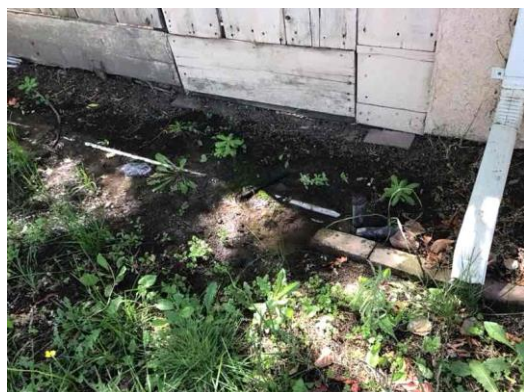
Photo 01

17. Inspection of the sprinkler system and related equipment is beyond the scope of this inspection. However, the sprinkler valve or pipe at the left rear was noted to be leaking. We recommend all leaks be repaired.

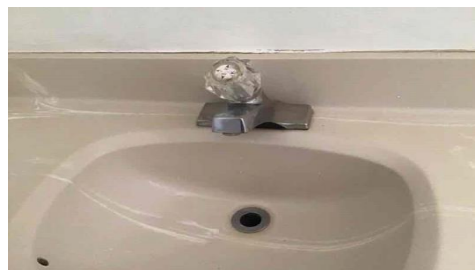
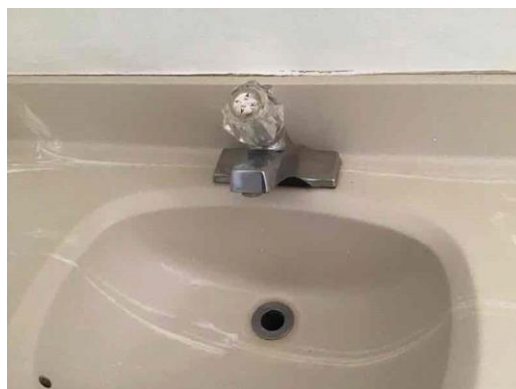
Photo 20

18. The sink faucet is leaking at the master bathroom. We recommend all leaks be repaired.

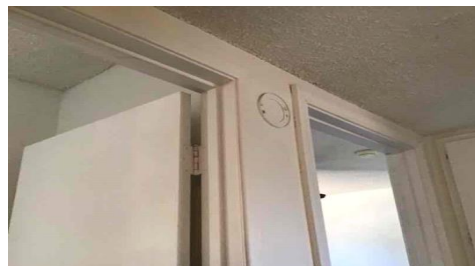
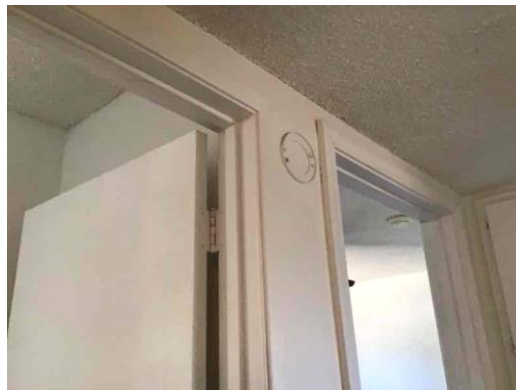
Photo 24

19. The installation of smoke detectors where missing or removed is required for added safety.

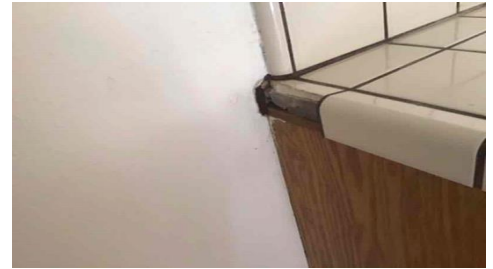
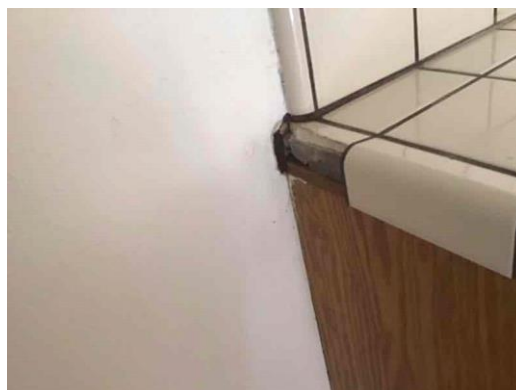
Photo 18

20. Cracked, damaged and loose kitchen countertop tiles should be replaced. Water leaking through non-sealed areas can cause damage. Damage caused by water seepage cannot be determined by this visual inspection.  
[\(See Photo 18\)](#)

- ! 6. Cracked, damaged and loose kitchen countertop tiles should be replaced. Water leaking through non-sealed areas can cause damage. Damage caused by water seepage cannot be determined by this visual inspection.  
([See Photo 18](#))
- 7. The kitchen countertop or backsplash tile surface is cracked and/or chipped. This is a cosmetic consideration and repairs are optional.
- 8. The kitchen cabinet shows evidence of typical minor wear.

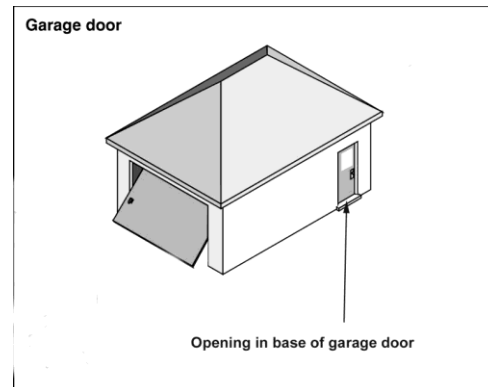
Illustration 3D

12. The walkway shows evidence of minor cracking. The cracks could be sealed for a better appearance and to prevent moisture intrusion.
13. The opening in the base of the side garage door should be covered or the door replaced to eliminate rodent or moisture entry.  
(See Illustration 3D)

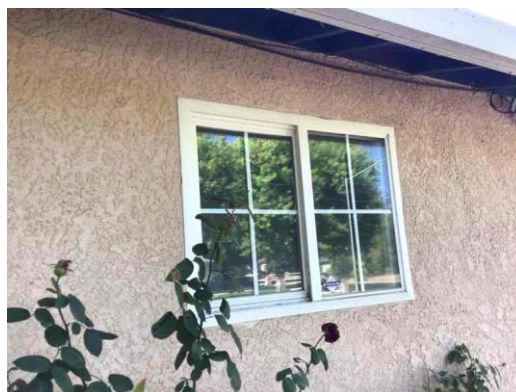
Photo 02

- 10. It may be desirable to replace the window screens where missing or damaged.  
([See Photo 2](#))

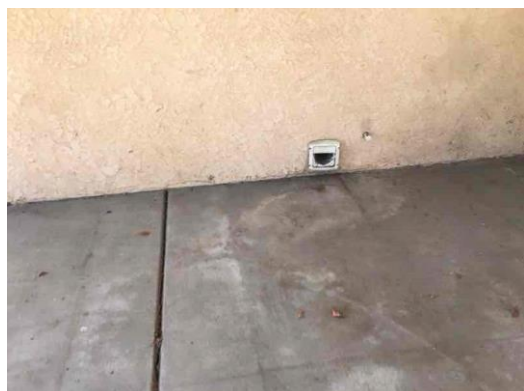
Photo 11

- ! 1. The installation of smoke detectors where missing or removed is required for added safety.  
([See Photo 24](#))
- 2. The exterior dryer hood/cap is damaged, missing or improper. We recommend the hood/cap be repaired or replaced with a new hooded damper at the termination of the dryer vent.  
([See Illustration 9A](#)) ([See Photo 11](#))

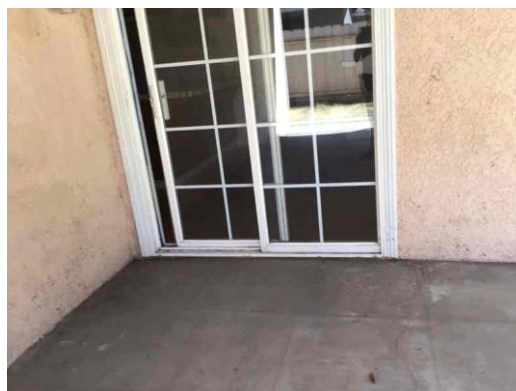
Photo 12

2. The screen for the sliding glass door is missing. The owner should be consulted regarding any screens that may be in storage. We recommend that it be replaced.  
(See Photo 12)

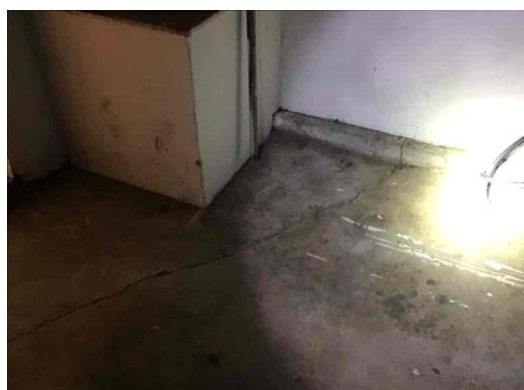
Photo 21

1. The garage floor slab has typical cracks. This is usually the result of shrinkage and/or settling of the slab. No further recommendations are given.  
[\(See Photo 21\)](#)
2. Water stains were evident in the attic at the time of inspection. It is unknown whether these stains are from a past or present leak. We recommend consulting the home owner for further information in regards to past or present repairs to the roof.

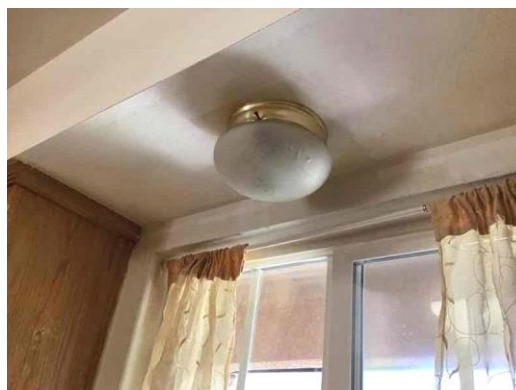
Photo 26

2. One of the lights in the kitchen is inoperative. If the bulb has not failed or the lights switched off, the circuit should be investigated and repaired.  
(See Photo 26)
