## Roof Inspection Report

**1820 Norman Way, Modesto**

Rafael Castaneda  
July 24, 2026  
Reg No. 103464 SP

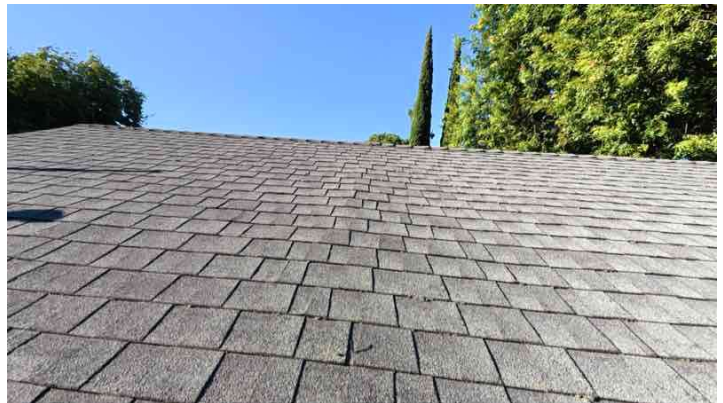
Photo 04

10. There are degranulated ridge caps.  
[\(See Photo 17\)](#) [\(See Photo 18\)](#)
11. During the course of this inspection we noted a few areas of the roof that appear to have an irregular surface noticeable through the roof covering. The shingles water shedding ability does not appear to be affected at this time. Interested parties are advised to contact a general contractor for further inspection.  
[\(See Photo 4\)](#)

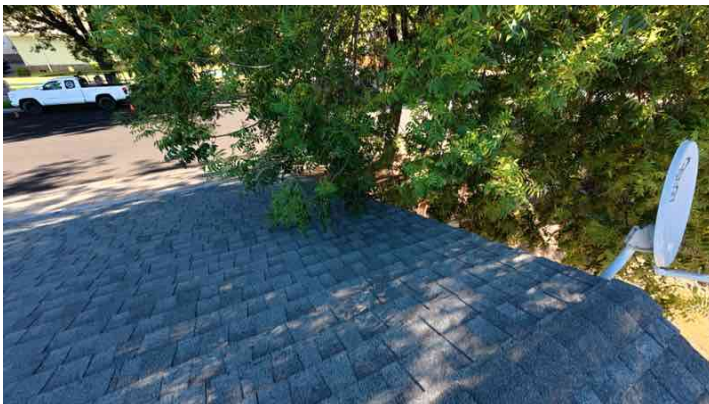
**Photo 11**

12. A tree is overhanging the roof's surface. Under windy conditions the branches will rub against the roof causing subsequent damage to the roof surface. To prevent premature roof wear, owner is to trim away all tree branches that can potentially rub against the surface of the roof.  
[\(See Photo 11\)](#)

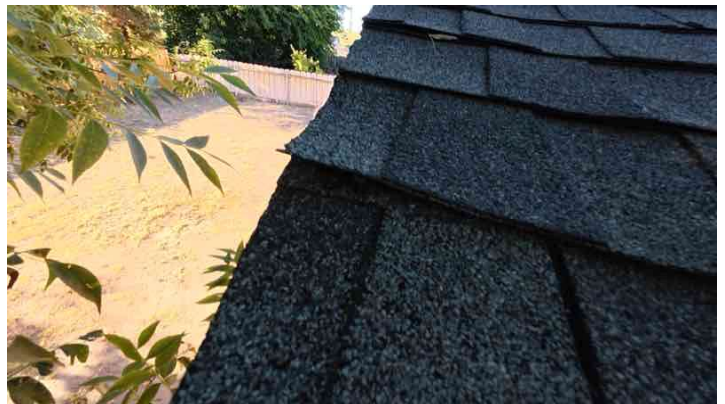
**Photo 12**

8. There are 1 areas where the fasteners used to secure the shingles have come loose and are working their way through the shingles.  
[\(See Photo 12\)](#)

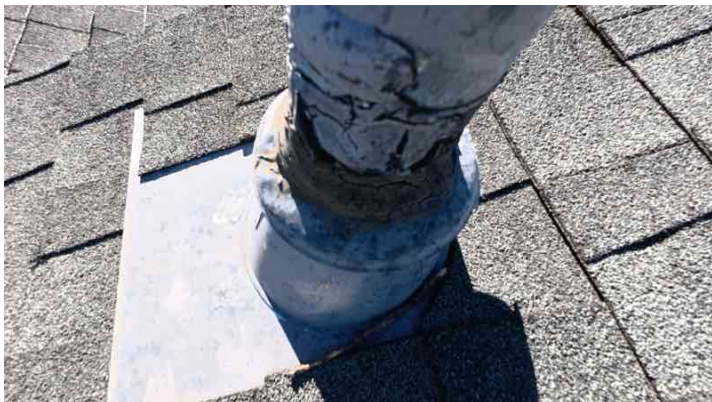
**Photo 13**

9. The vent pipe storm collar has been previously sealed with mastic to prevent leakage, the mastic has deteriorated and is no longer functional.  
[\(See Photo 13\)](#)

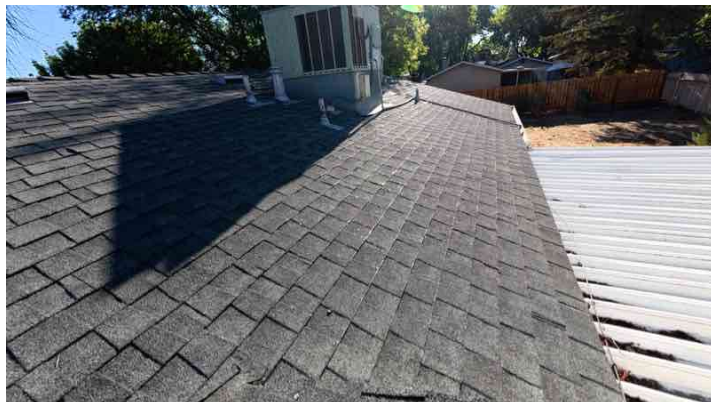
**Photo 14**

13. The shingles protective granules are breaking loose exposing the shingle panels to 'burnout' and subsequent leakage.  
[\(See Photo 14\)](#) [\(See Photo 15\)](#) [\(See Photo 16\)](#)

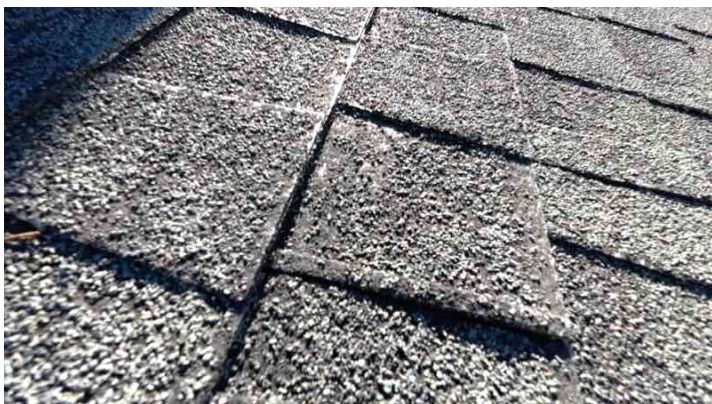
**Photo 15**

16. The main roof and low slope roof appears to be vulnerable to leakage and is beyond practical repair.  
[\(See Photo 15\)](#) [\(See Photo 19\)](#)

If a bid for a new roof is desired please contact HomeGuard Incorporated for re-roofing options.

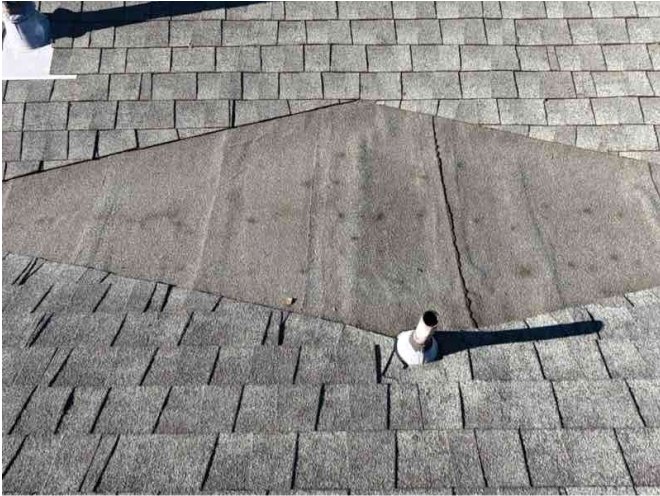
**Photo 19**

14. On the low slope portion of the roof:  
[\(See Photo 19\)](#)
15. The low slope roof area shows degranulation, this will exposed the roof membrane to burn out and this will lead to a leakage.  
[\(See Photo 19\)](#)
