## WOOD DESTROYING PESTS AND ORGANISM INSPECTION REPORT

| Building No.<br><b>1820</b> | Street<br><b>Norman Way</b> | City<br><b>Modesto</b> | ZIP<br><b>95350</b> | Date of Inspection<br><b>7/24/2026</b> | Number of Pages<br><b>Page 1 of 9</b> |
| General Description: <b>This is a one story single family dwelling with stucco exterior.</b> | | | | Inspection Tag Posted: <b>Garage</b> | |

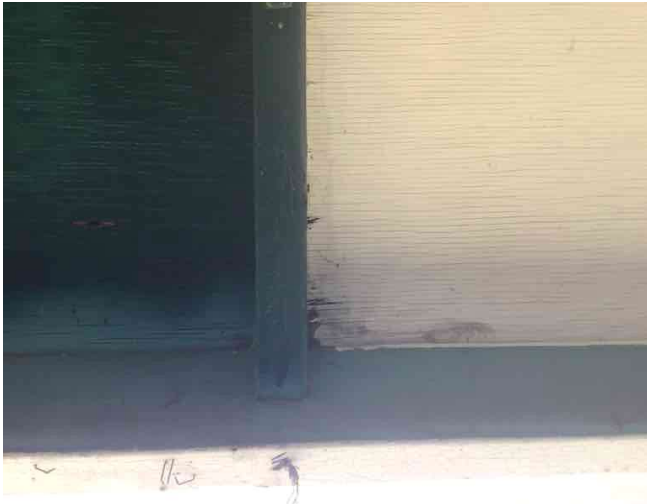
Photo 01

- 1A.** FINDING: The roof sheathing has been damaged by fungus where indicated on the diagram. The contributing moisture source appears to have been caused by a failure of the roof covering.  
(See Photo 1)

RECOMMENDATION: Remove and replace the damaged sheathing to correct this condition. This bid *Estimated Cost* includes repair of the roof covering if disturbed by our repairs. If existing gutters need to be removed to perform the repairs then our bid also includes reinstallation of original gutters. If it becomes necessary or desirable to install new gutters this will be done only if authorized and at an additional expense. The guarantees on the roof covering are limited to the areas where the repairs were performed.

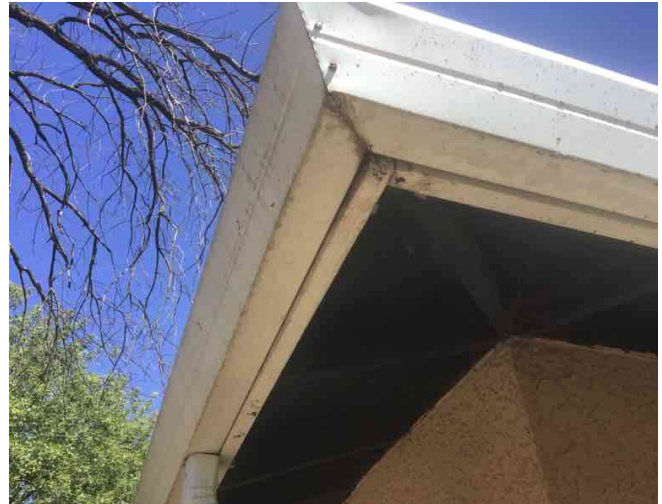
Photo 02

- 1B.** FINDING: The fascia has been damaged by fungus where indicated on the diagram. The contributing moisture source appears to have been caused by a failure of the roof covering and/or exposure to weather.  
(See Photo 2)

RECOMMENDATION: Remove and replace the damaged fascia to correct this condition. This bid *Estimated Cost* includes repair of the roof covering if disturbed by our repairs. If existing gutters need to be removed to perform the repairs then our bid also includes reinstallation of original gutters. If it becomes necessary or desirable to install new gutters this will be done only if authorized and at an additional cost. The guarantees on the roof covering are limited to the areas where the repairs were performed.

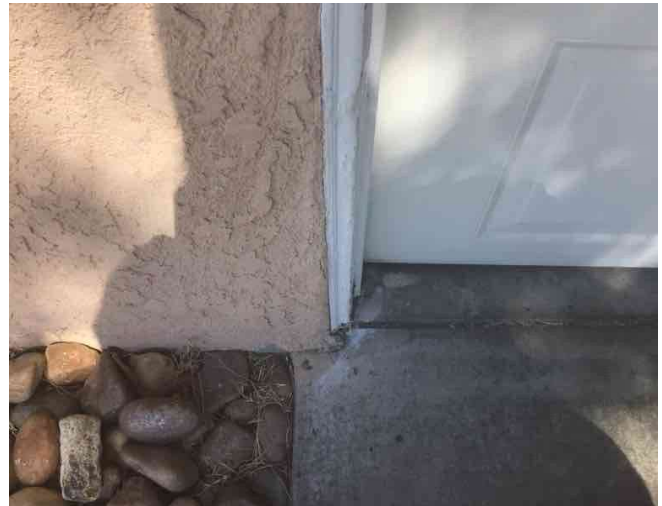
Photo 04

- 1D.** FINDING: The stucco molding has been damaged by fungus at the base. The contributing moisture source appears to be exposure to the weather.  
([See Photo 4](#))

RECOMMENDATION: Remove and replace all the damaged wood members. If any damage is found to  
*Estimated Cost* extend into any enclosed areas a supplemental report and bid will be issued.

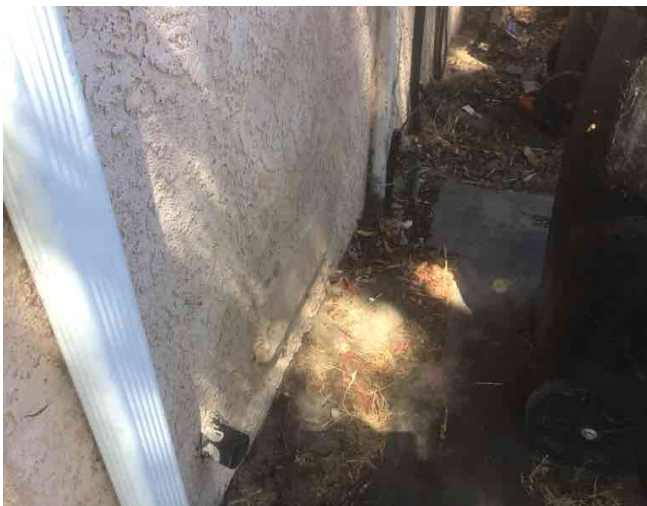
Photo 05

**3A.** FINDING: This home was constructed without the use of a weep screed at the base of the stucco. Although this was an accepted construction method it does create an area that can allow subterranean termites to access the home without being detected. This area can also allow condensation to build up and not drain properly.  
[\(See Photo 5\)](#)

RECOMMENDATION: If further information is desired it will be necessary to install a series of test holes  
*Estimated Cost* to allow for further inspection. All findings, recommendations and bids will be issued in a supplemental report. If no additional damage is noted, the test holes in the stucco will be patched back up. We will attempt to match the texture as close as possible, however the texture may differ from the existing.

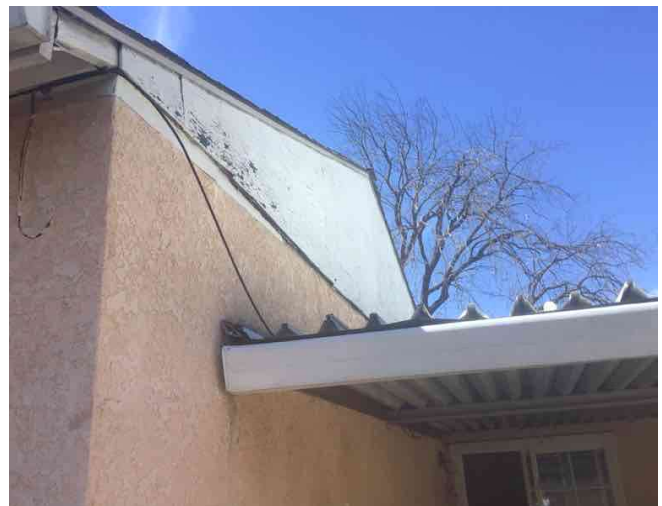
Photo 06

- 1E.** FINDING: The siding has been damaged by fungus at the area above the patio cover adjacent to the garage rear wall. The contributing moisture source appears to be exposure to the weather.  
([See Photo 6](#))

RECOMMENDATION: Remove and replace all the damaged wood members. If any damage is found to  
*Estimated Cost* extend into any enclosed areas a supplemental report and bid will be issued.

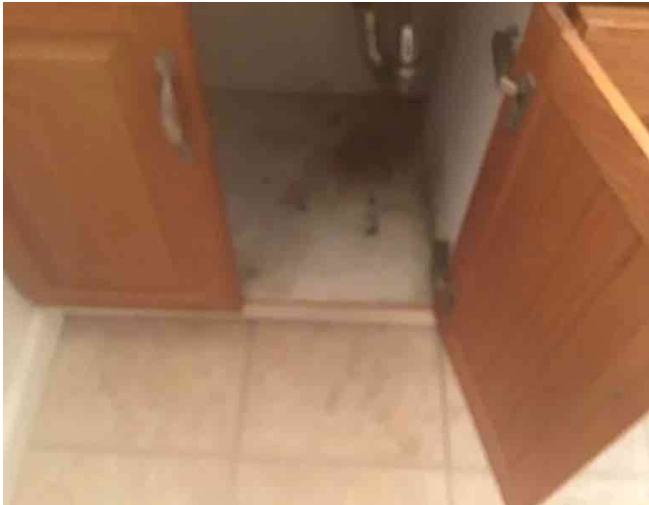
Photo 09

- 1H.** FINDING: There is a plumbing leak at the master bathroom sink drain and faucet handle.  
([See Photo 9](#)) ([See Photo 10](#))

RECOMMENDATION: Reseal or repair this leak in the most practical way.  
*Estimated Cost*
